VERIFICATION REQUIREMENTS FOR GAS PROTECTION SYSTEMS

Technical Guidance for
Developers,
Landowners and
Consultants

Yorkshire and Humberside
Pollution Advisory Council

Version 1.0 – January 2016

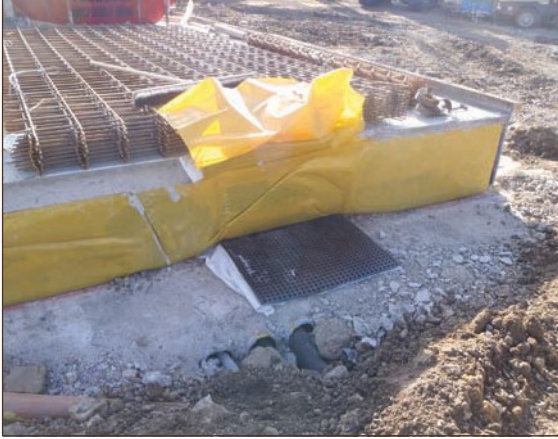
Figure A4.7 Geovent protruding out of the frontage of the unit. Gas membrane along the sides of the slab preventing lateral gas ingress (courtesy Alderburgh Group)

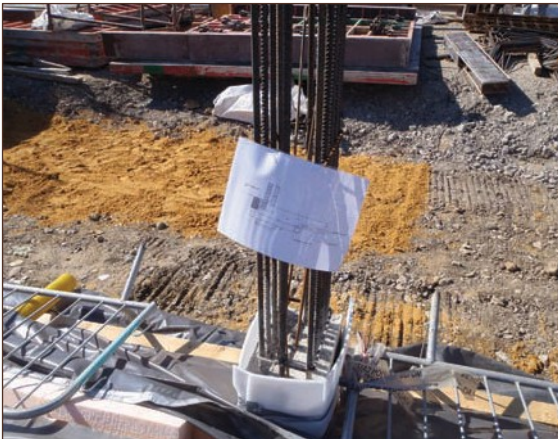
Figure A4.9 On site schematics to aid construction workers build the gas protection system (courtesy Alderburgh Group)

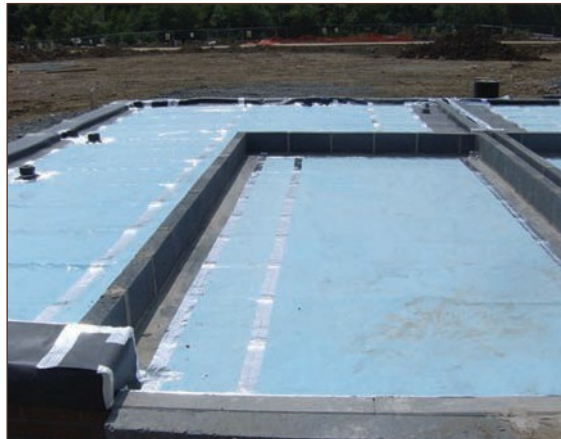
Figure A4.10 Almost complete coverage available for inspection, minimal jointing, service entries suitable distance from walls, light traffic (courtesy Smith Grant)

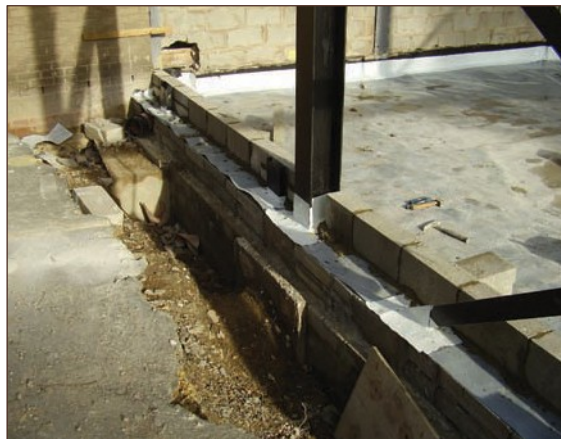
Figure A4.12 Good edge detail across cavity (courtesy PAGEotechnical Ltd)

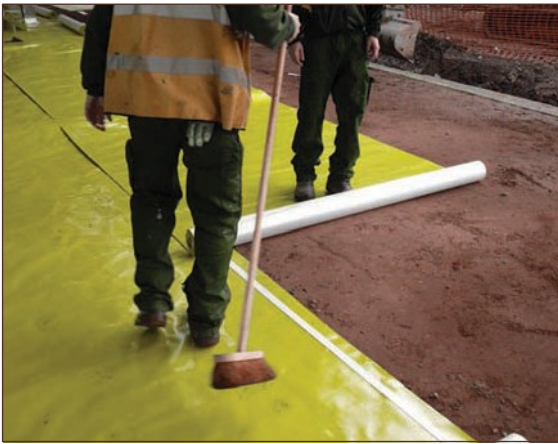
Figure A4.15 LDPE type gas membrane overlap and double sided tape. Sand blinding to protect underside of gas membrane (courtesy A Proctor Group)

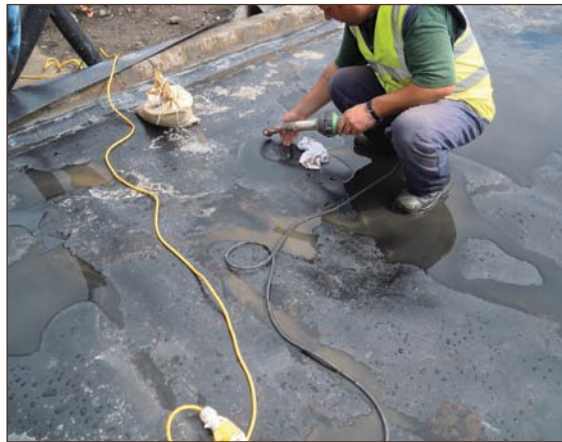
Figure A4.40 CO₂ injection integrity testing (courtesy Landline Ltd)

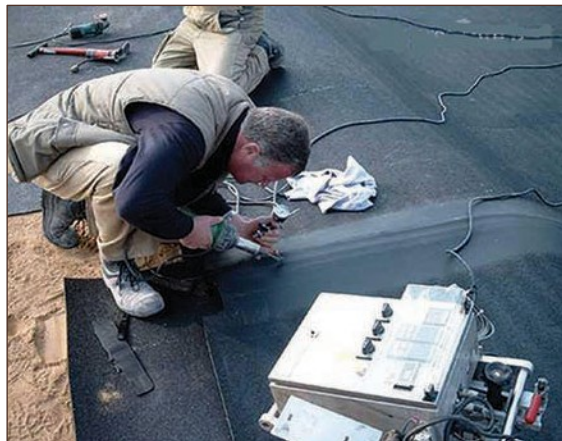
Figure A4.42 Air pressure testing (courtesy GSE Environmental)

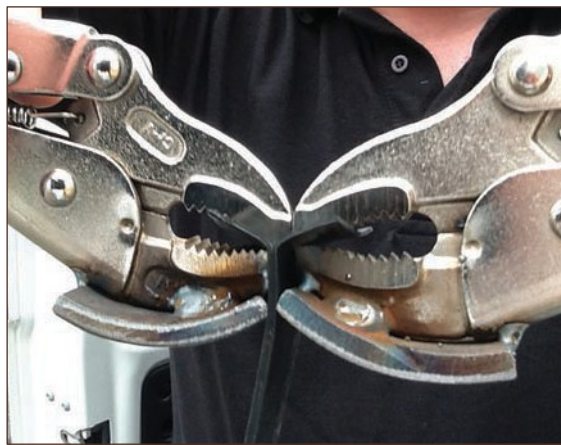
Figure A4.46 Testing a weld with 'dog bone' grips (courtesy MEC Environmental Ltd)

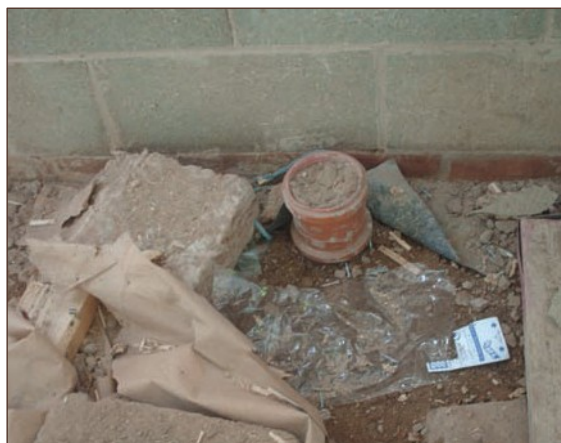
Figure A4.48 Loose nails and over construction debris likely to be left in place beneath gas membrane – poor preparation of gas membrane prior to sealing service penetration (courtesy Card Geotechnics Limited)

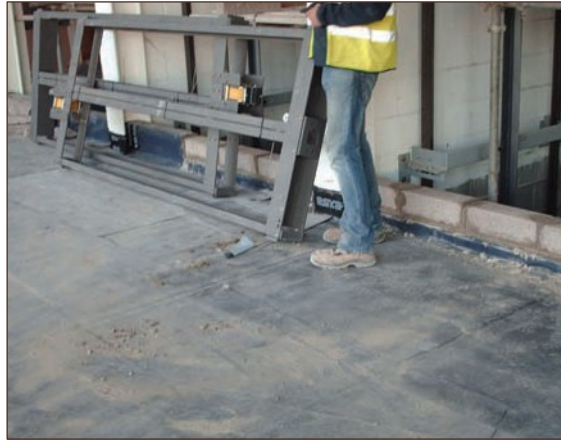
Figure A4.50 *Large/heavy/sharp objects being moved over unprotected gas membrane (courtesy Card Geotechnics Limited)*

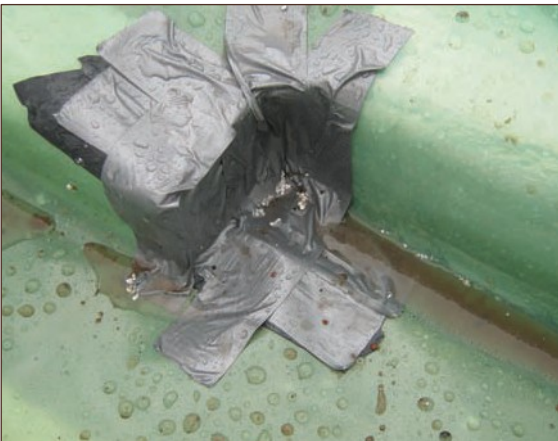
Figure A4.69 Attempt at corner detailing using non-proprietary duct tape (courtesy Smith Grant)

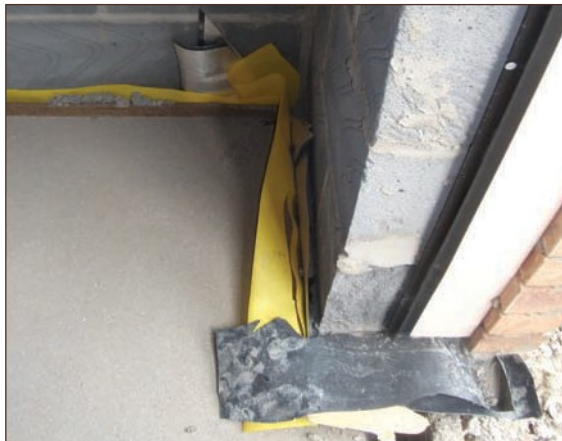
Figure A4.70 Inadequate corner detailing. The use of preformed proprietary products would have avoided such bad practice (courtesy NHBC)

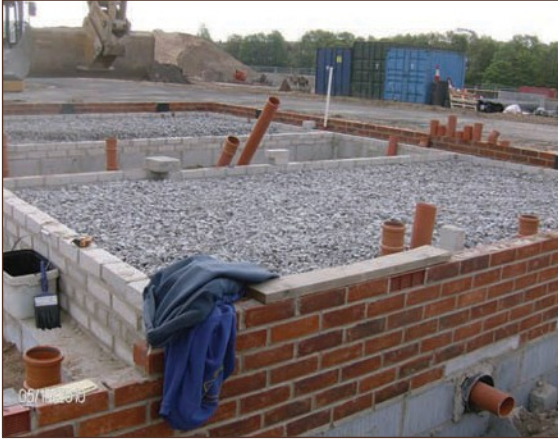
Figure A4.85 Clean single sized stones with no fines acting as venting media, however no ventilation gaps in internal sleeper walls (courtesy Smith Grant)

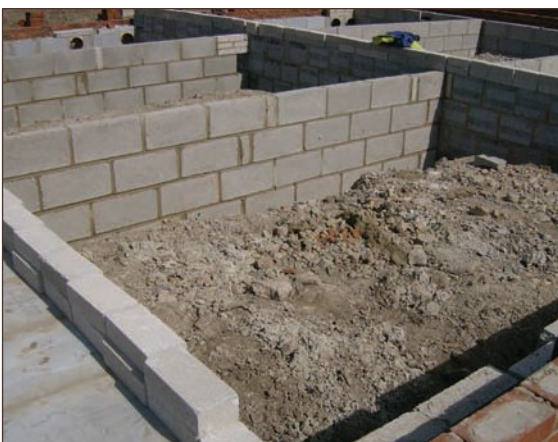
Figure A4.89 No ventilation in internal sleeper wall (courtesy Smith Grant)
