STAMFORD CONSERVATION APPRAISAL

Review and Extension November 2011 | Designated October 1967

South Kesteven District Council
STAMFORD • GRANTHAM • BOURNE • THE DEEPINGS

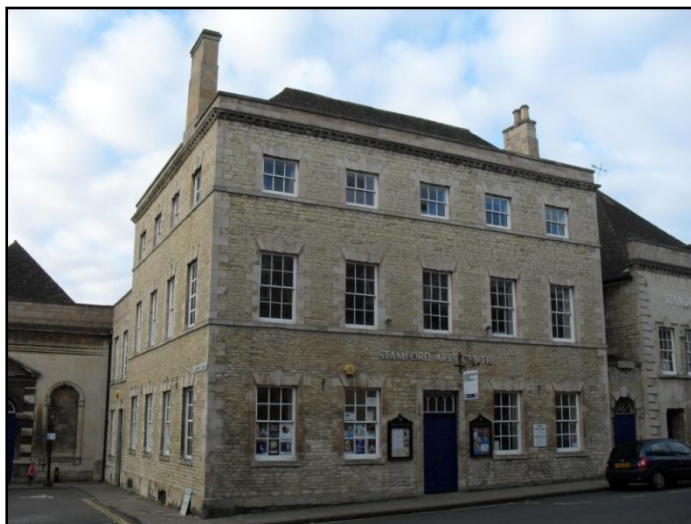
Fig. 1. Stamford Arts Centre with flush freestone dressings.

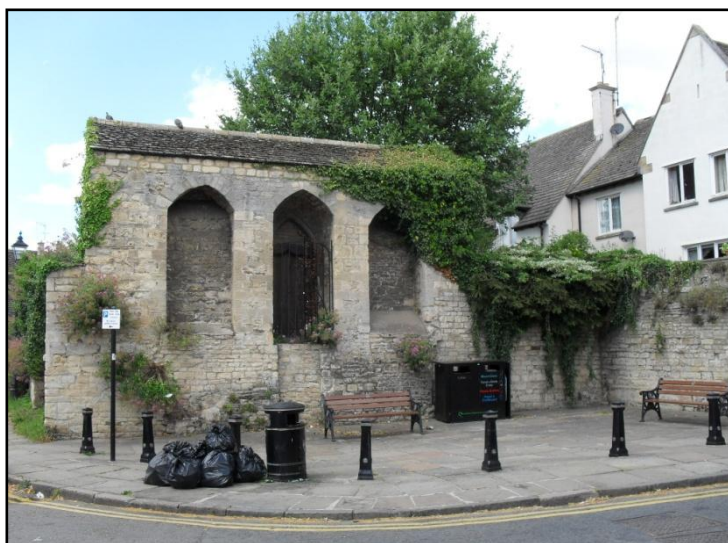
Fig.2. Remains of the Great Hall, Bath Row.

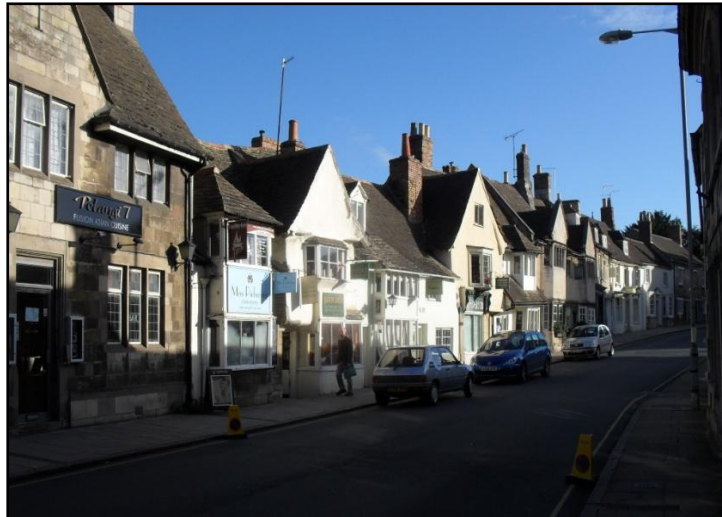
Fig. 3. Medieval buildings on the north side of St Paul's Street

The character of the town began to change as stone began to replace timber in the construction of domestic buildings. Merchants built large stone houses with vaulted undercrofts which had independent access from the street where goods were traded, No. 13 St Mary's Hill is a surviving example. Large town houses with communal open halls, some with storeyed cross gables, began to be built in the 13th century, examples of which can be seen on the north side of St Paul's Street. The churches were also rebuilt and embellished; the

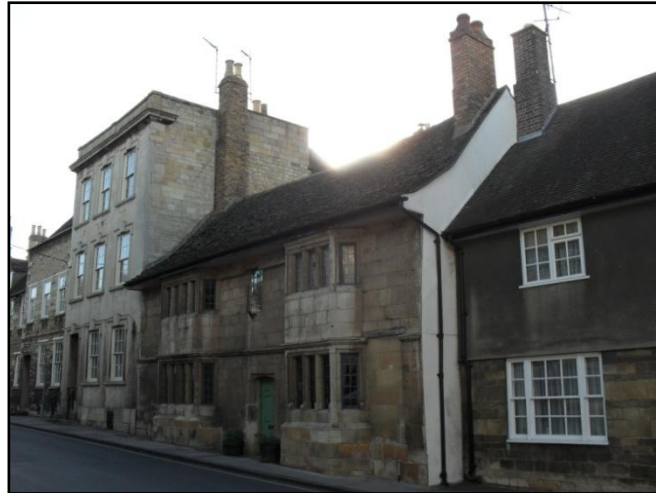
Fig. 5. No. 32 St Paul's Street.

The character of the town began to change in the 17th -18th centuries; formerly derelict sites were redeveloped and timber framed buildings were re-faced with stone or laths and plaster to cover the exposed woodwork and Collyweston slates replaced thatched roofs. The Stamford Vernacular style evolved and was the dominant style until the late 17th century. The facades were marked by bays which extended up each floor, sometimes finishing below the eaves but usually running up into the gable ends which have finials and kneelers often decorated with a date slab. Examples can be seen throughout the medieval core and include Nos. 32 Broad Street, 12 and 32 St Paul's Street.

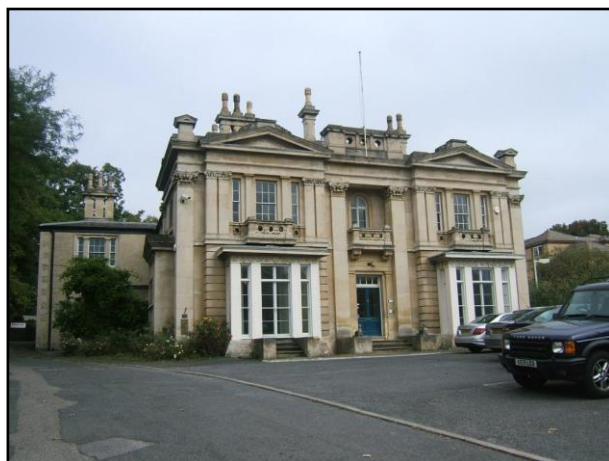
Fig. 16. Rock House and adjacent petrol station.

- The setting of Rock House is adversely affected by the adjacent petrol station which also breaks the continuity of the building frontage along the street.
- No. 48, currently occupied by Jackson Building Centre, is inconsistent with the character of the street in terms of design and materials.
- Some of the buildings have lost their traditional window designs, and in instances have replacement upvc windows which detract from the character of individual buildings and that of the street overall.
- The car park adjacent to Truesdale Hospital breaks the continuity of the frontage along the street.
