Appraisal and Management Plan Designated 1980 Review September 2016

The conservation area at Langtoft was designated in 1980. The purpose of this document is to define the special interest of the conservation area and assess the action needed to protect and enhance the special qualities of the conservation area. The conservation area appraisal and management plan is split into three sections:

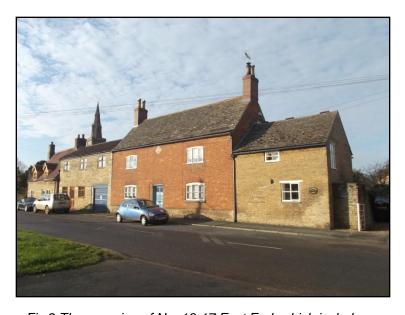
Fig.3 No.31 East End, Sycamore House, identified as a positive unlisted building and displaying features typical of the architecture found in the village eg, pantile or slate roofs, harmonious use of stone with quoins dressings, timber casement and sliding sash windows. The range to the left (west) has a dovecote and a fire insurance plaque on the gable end.

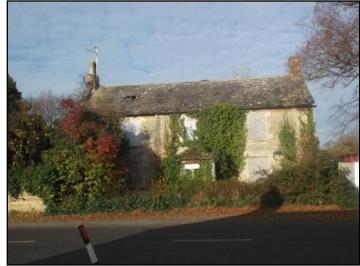
Fig.11 No.47 East End, is in a very poor state of repair, and is urgently in need of a new use and works to make it wind and weathertight.

The buildings are generally in good condition with the exception of No. 47 East End and associated barns, which are vacant and in a very poor state of repair with the former dovecote in ruins. The former school building appears to be vacant and is in need of some localised repairs to the brickwork as well as repairs to re-instate the eastern chimney.

No.47 East End and the adjacent barn are on the Councils internal at risk register. The condition of buildings will be monitored and appropriate action instigated where necessary. The Planning (Listed Building and Conservation Areas) Act 1990 gives the local authority powers to protect significant buildings through the following measures:

- No 47 East End, a Grade II listed farmhouse and associated barns are on the Council's 'at risk' register and in a very poor state of repair and require a sympathetic new use and conversion. The building has previously gained approval for a conversion scheme and the applicant is currently in the process of applying for amendments to the scheme.
- Loss of character arising from inappropriate alterations (windows, doors, rendering and boundary treatments).
- Traffic and heavy goods vehicles along Peterborough Road detracting from a village that has a fairly quiet character.
